DEPARTMENT OF PUBLIC UTILITIES

INCIDENT REPORT

17 Danny Road, Hyde Park, Massachusetts

November 3, 2010

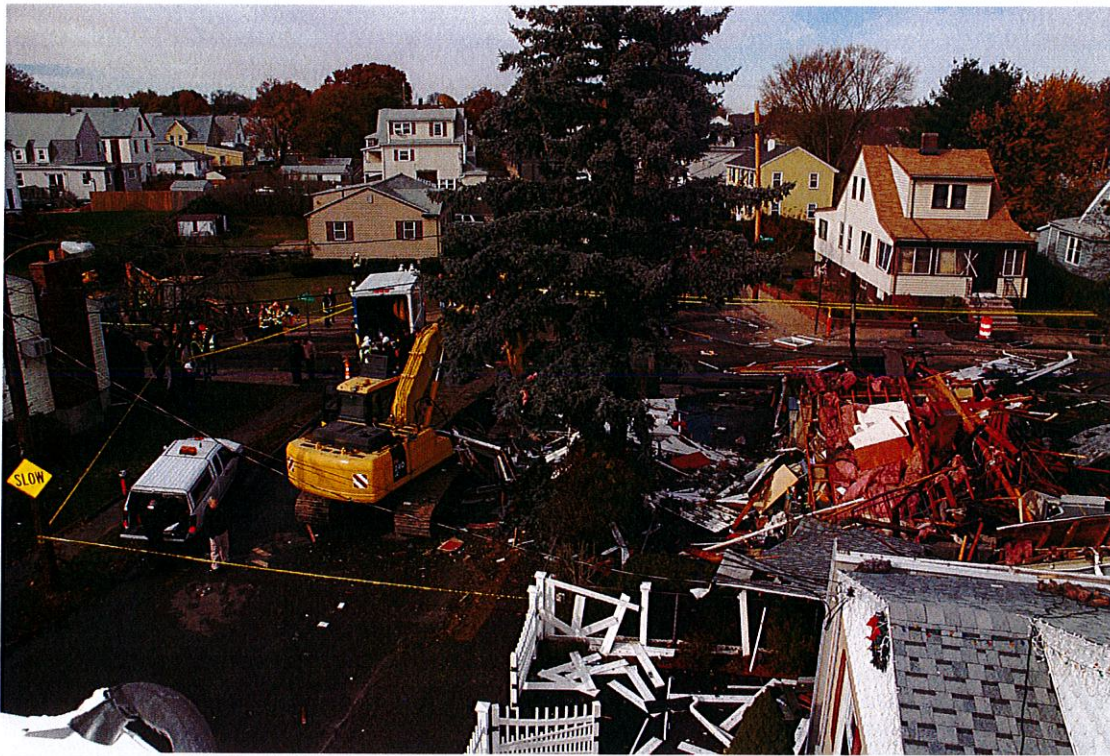
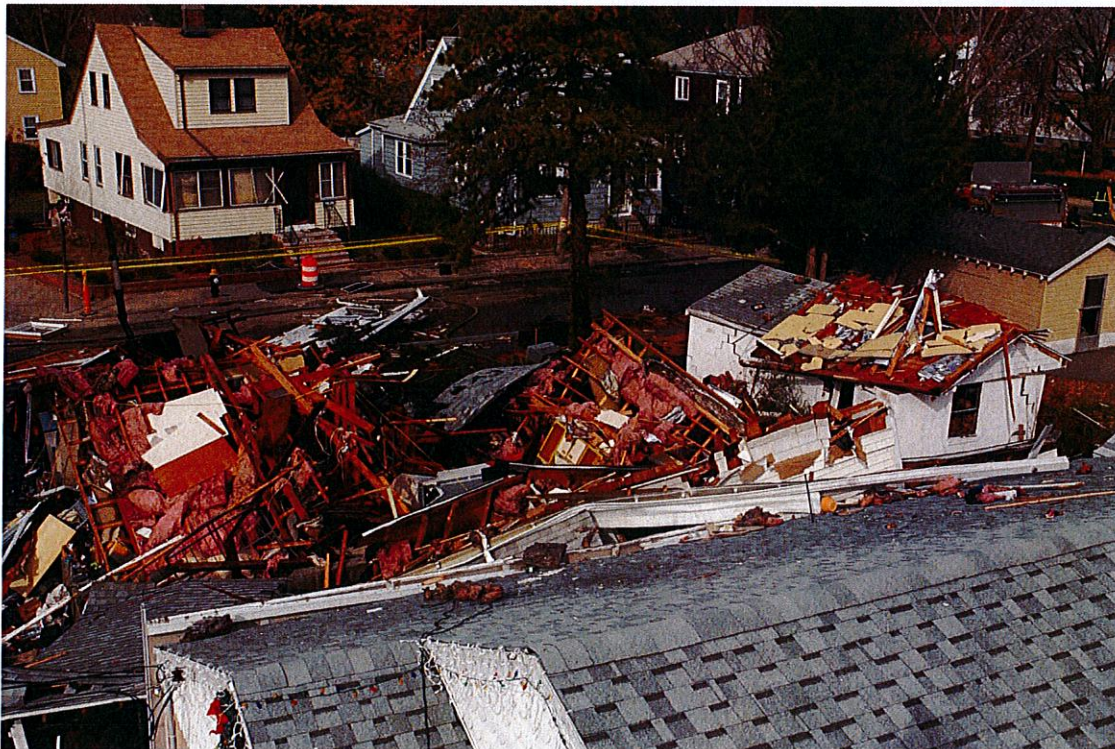
The explosion completely destroyed the house (Exh 5(a)) and it also caused damage to eight other houses on Danny Road, Reynold Road and Chesterfield Street (Exh. 5(a)).

Exhibit 5(a) - 17 Danny Road, Hyde Park (11-3-10)

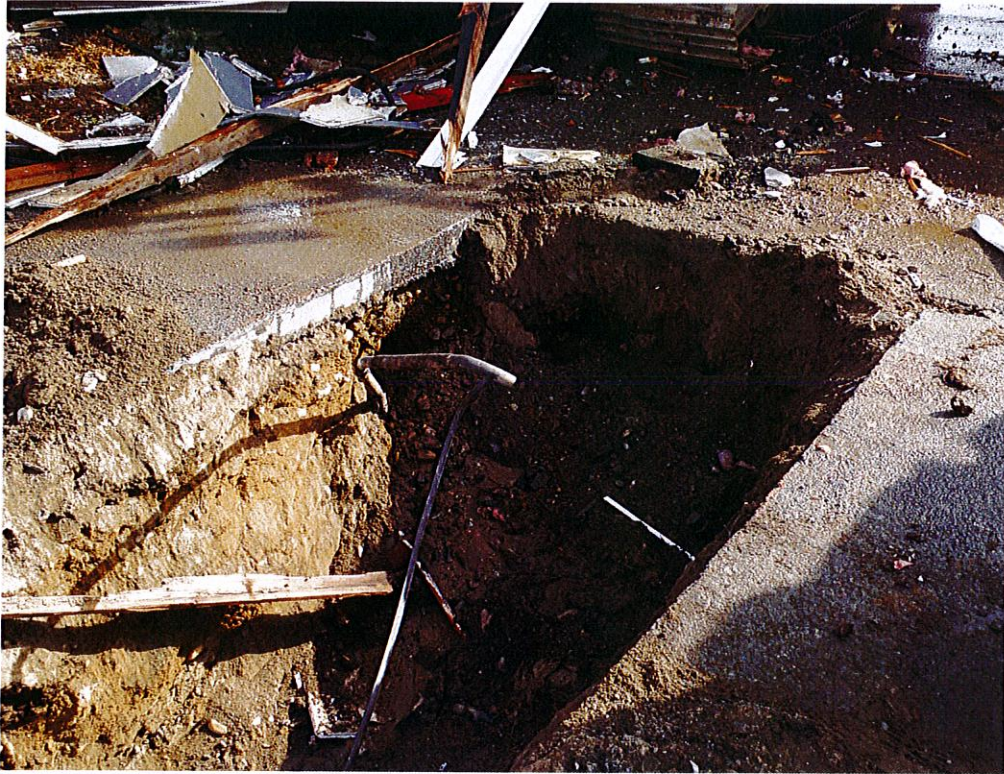
The second section of the gas service was not capped it was partially located and buried in the sidewalk area (Exh. 5(b)). When NSTAR excavated and exposed this section of the gas service, the curb valve was found to be broken in two (Exh. 9(d)).

Exhibit 5(b) Broken Gas Service - House Side, supplying
17 Danny Road (11-3-10)

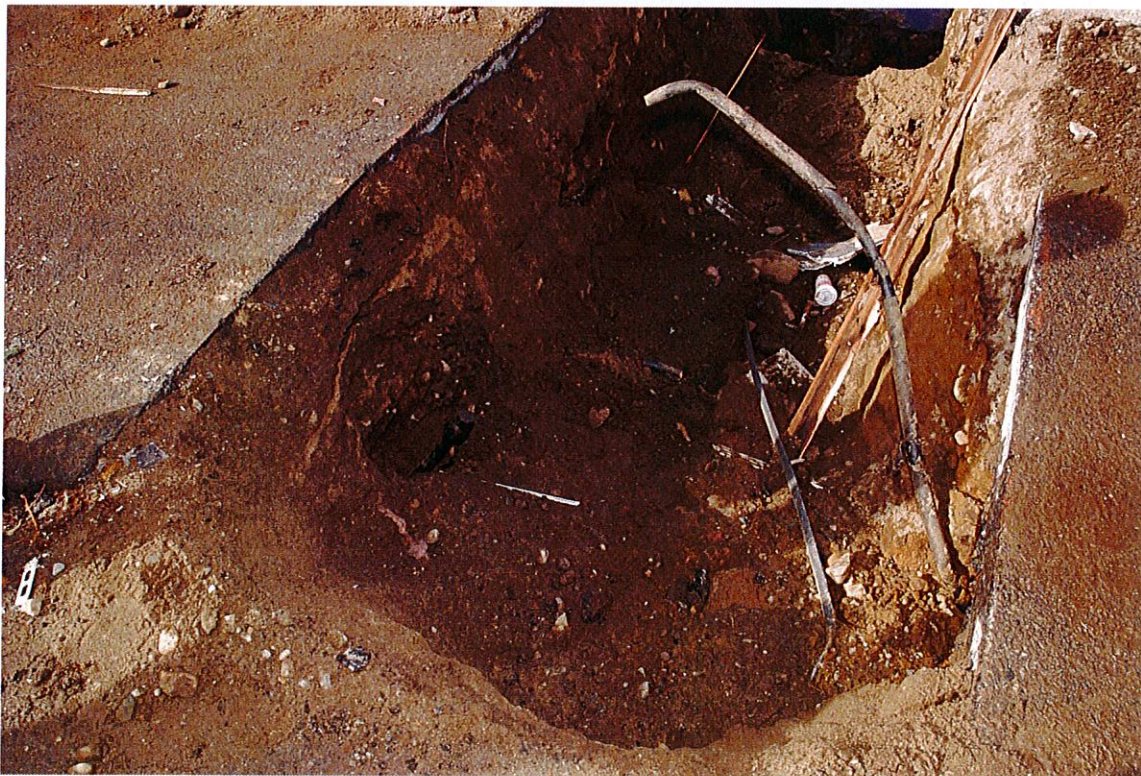
The first NSTAR personnel to arrive at the scene found the gas service leaking and that a broom stick handle had been jammed into the open end of the gas service that was still connected to the gas main. This had been done in an attempt to slow the escape of gas from the gas service (Exh. 8). The first NSTAR personnel to arrive onsite were able to stop the flow of gas by cutting and capping the gas service (Exh. 8).

Exhibit 5(c) Cut and Capped Gas Service - Street Side, supplying
17 Danny Road (11-3-10)

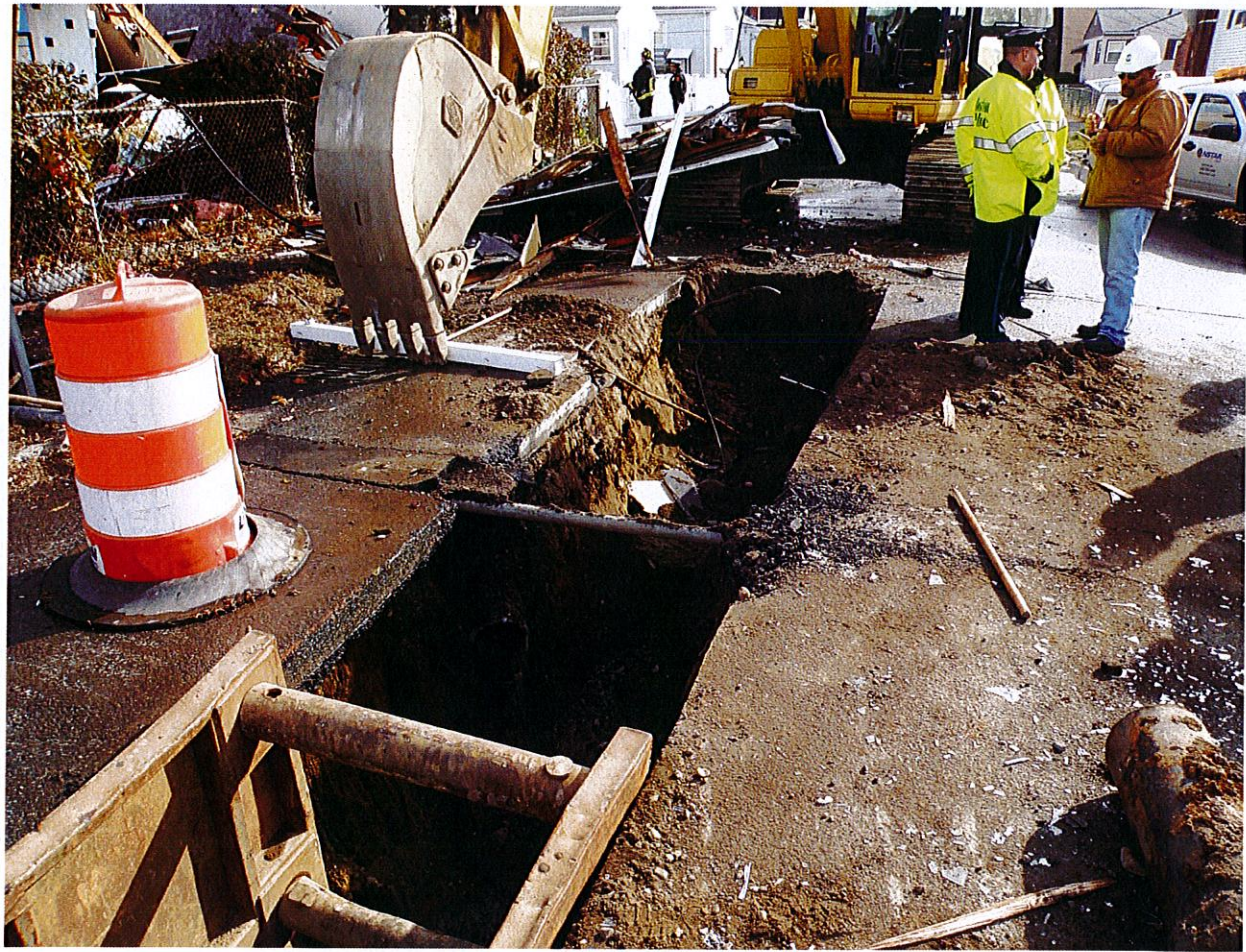
On November 3, 2010, while operating an excavator machine along Danny Road, DeFelice hit and damaged a one (1) inch diameter NSTAR gas steel service (Exh. 2, 5(b)).

Exhibit 5(d) DeFelice Excavation on 17 Danny Road (11-3-10)

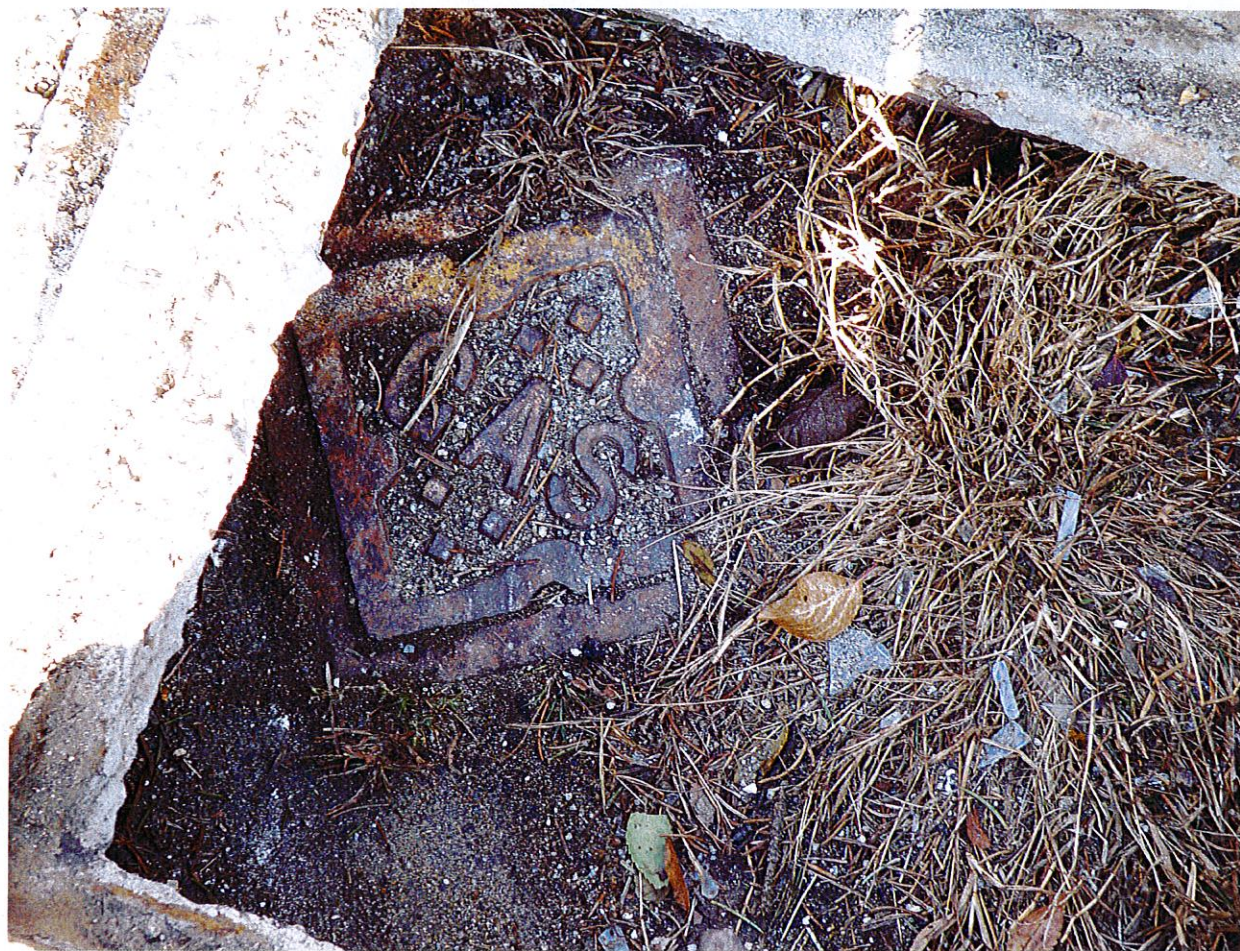
Exhibit 9(a) – Gas Service Valve Box Cover of Gas Service supplying
17 Danny Road (11-3-10)

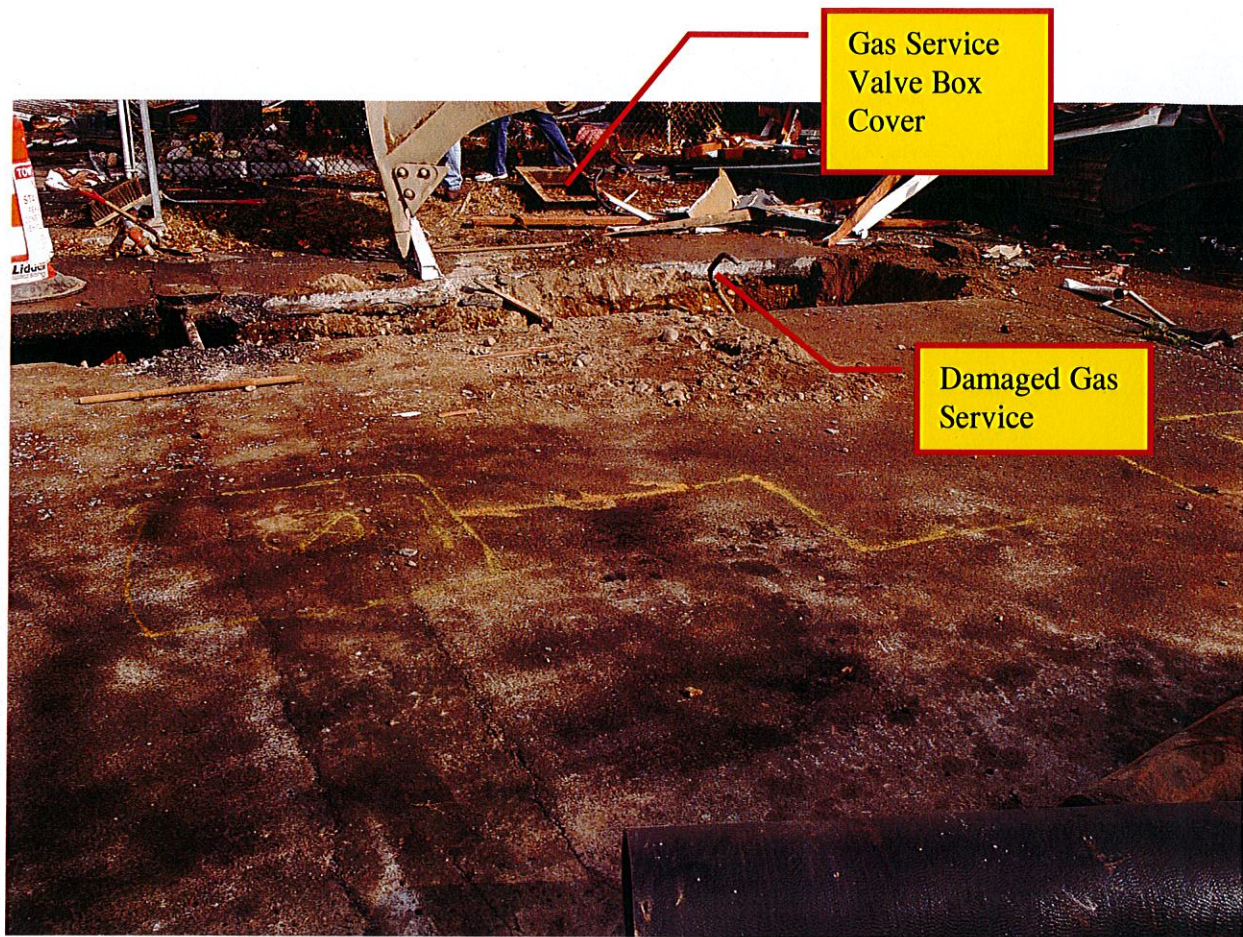
On November 3, 2010, DeFelice began to excavate on Danny Road in an easterly direction (Exh. 3). Adjacent to the excavation and located in the grass area between the street and sidewalk was the gas service valve box for 17 Danny Road; 1 (Exhs. 9(a), 9(b), 11 at 32-33). The excavator damaged the one (1) inch gas service that was located approximately seventeen (17) feet beyond the property line of 17 Danny Road at the intersection of Danny Road and Reynolds Road (Exhs. 9(b), 11 at 25). After damaging the gas service, the DeFelice excavator operator began to hand dig around the damaged gas service, while another employee walked towards the house (Exh. 3). The employee smelled natural gas as he approached the house (Exh. 3). He immediately went back and told the excavator operator who was hand digging around the gas service (Exh. 3). The excavator operator pulled the gas service out of the ground in an attempt to vent the natural gas to the atmosphere (Exh. 3). Then both

Exhibit 9(b) – Gas Service Valve Box in Relation to Damaged Gas Service

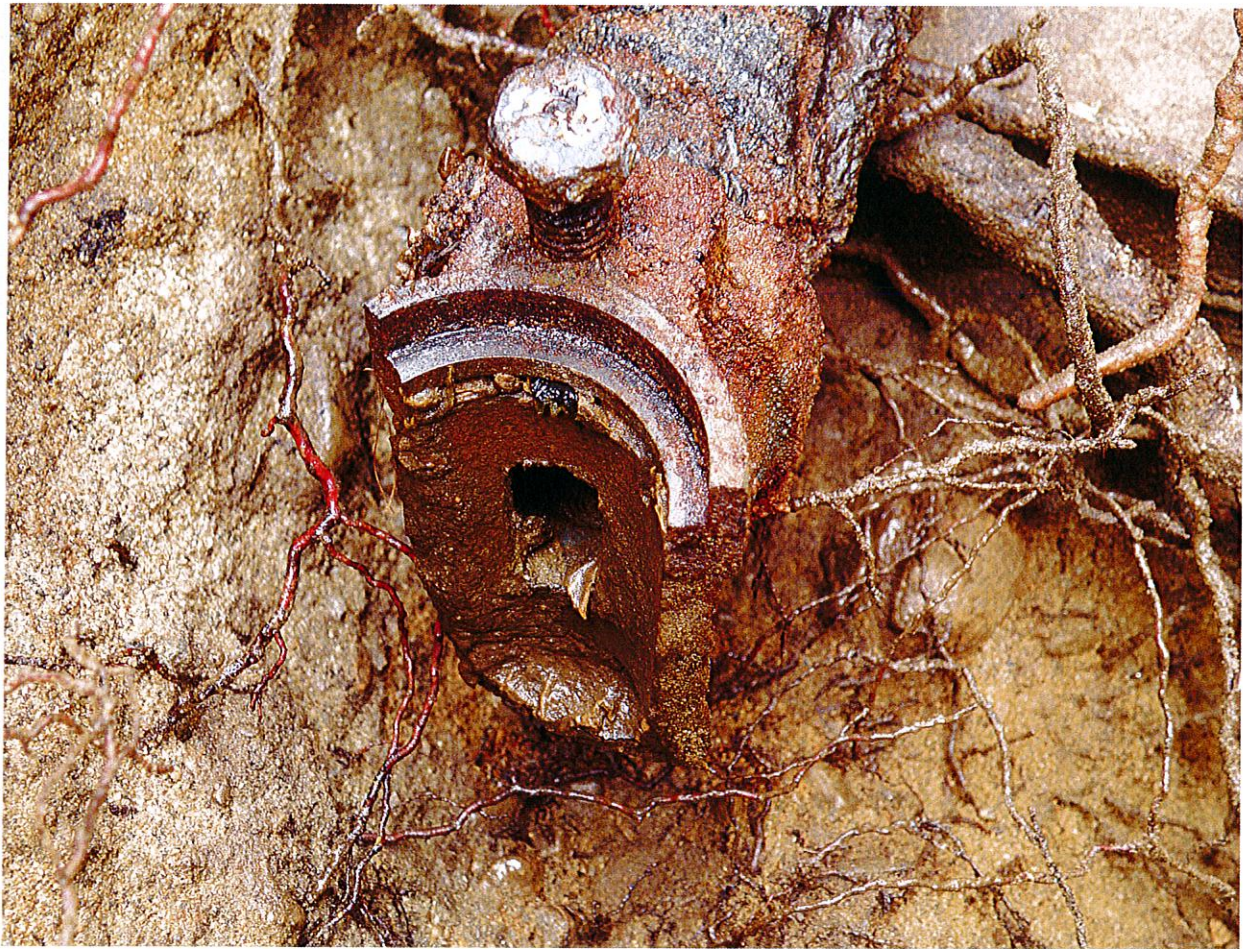
The third section of the gas service contained the other half of the broken curb valve and terminated in the basement of 17 Danny Road (Exh. 9(c)). Inside the basement of 17 Danny Road, the gas service had been connected to the service regulator, the gas service pipe was broken at this point (Exh. 10(a), (b)). Installed at the end of the gas service inside the basement was a service shut off valve that had been pulled against the foundation wall (Exh. 10(a)).

Exhibit 9(c) – Broken Gas Service Valve – House Side, supplying
17 Danny Road

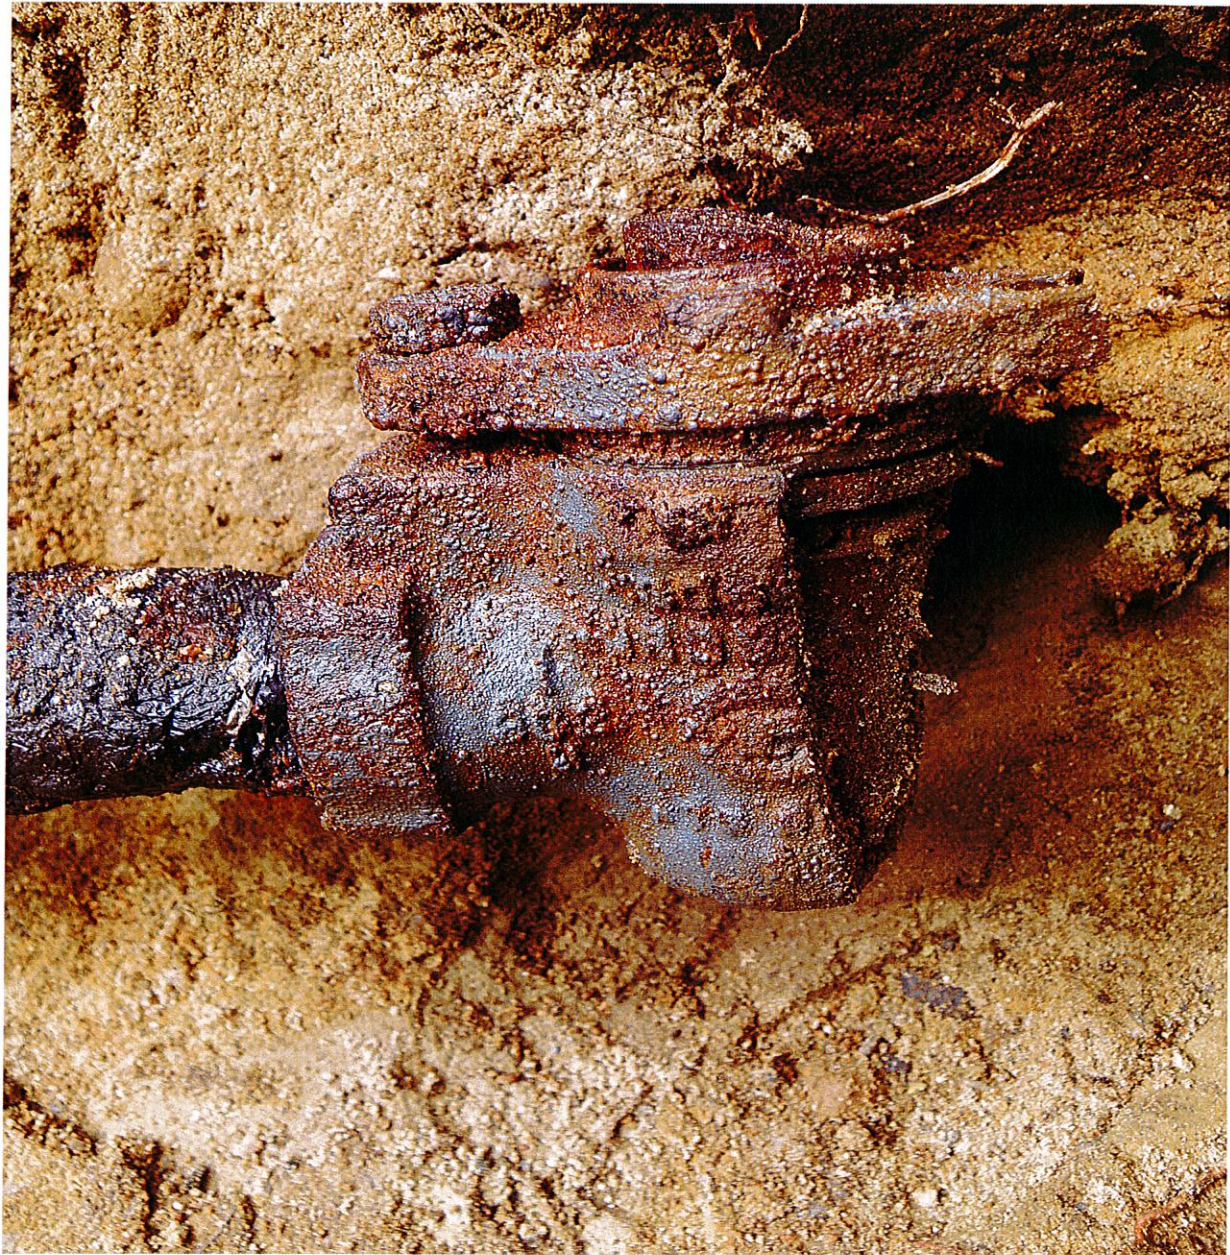
The broken gas service valve at the street line and the broken gas pipe at the service regulator inside of 17 Danny Road, were the most likely sources of the release of gas. The escaping gas accumulated inside of 17 Danny Road, and was ignited by an undetermined source inside the house.

Exhibit 9(d) – Broken Gas Service Valve – Street Side, supplying
17 Danny Road

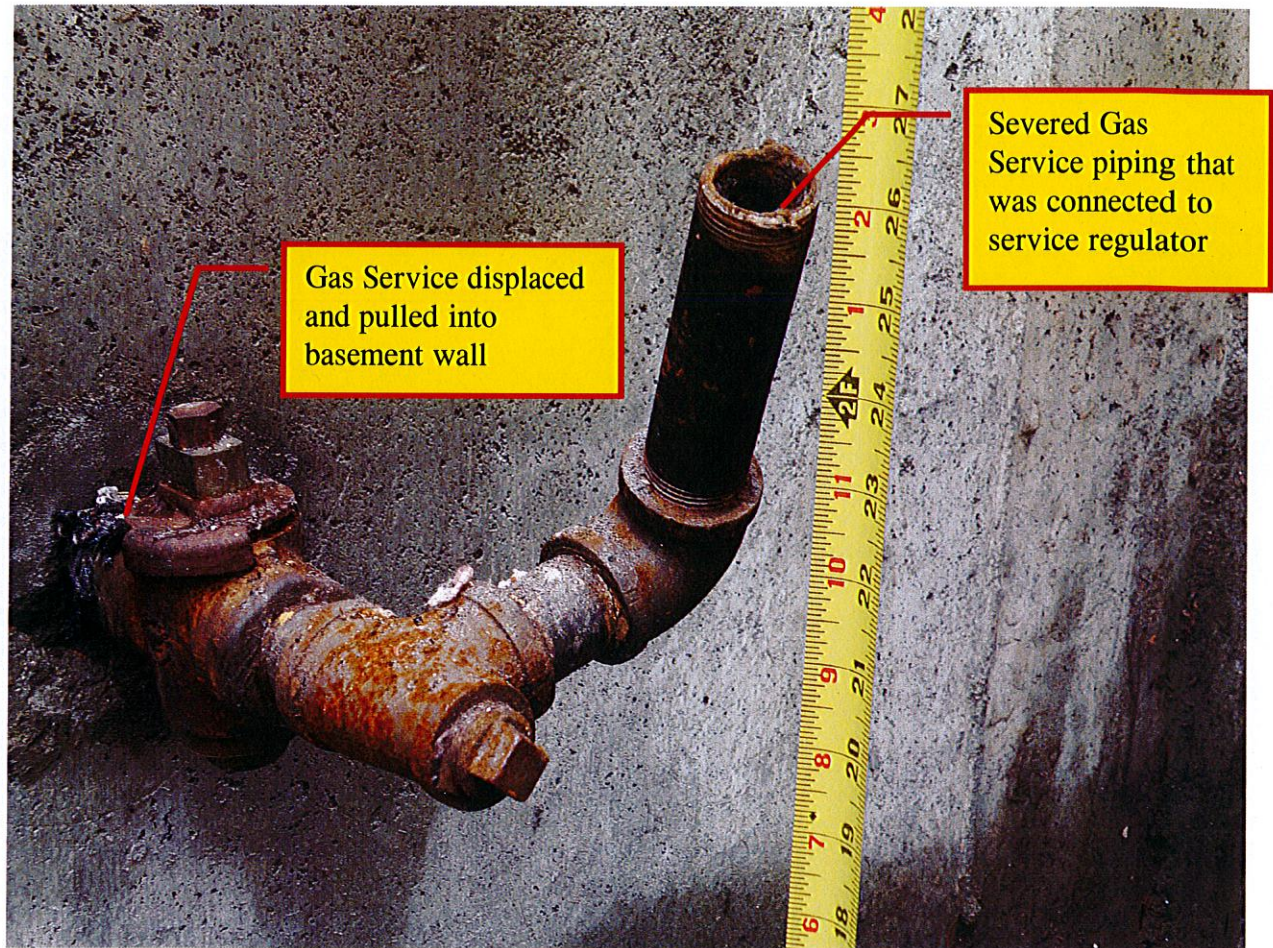
The cause of the fire/explosion was the main gas pipe in the basement being pulled from the interior gas piping at the regulator meter. The natural gas pressure from the street to the regulator meter was 25 lbs in and the in house pressure to the gas appliances is less than a 1/4 lb/in.

Exhibit 10(a) – Displaced and Severed Gas Service Piping Inside of
17 Danny Road

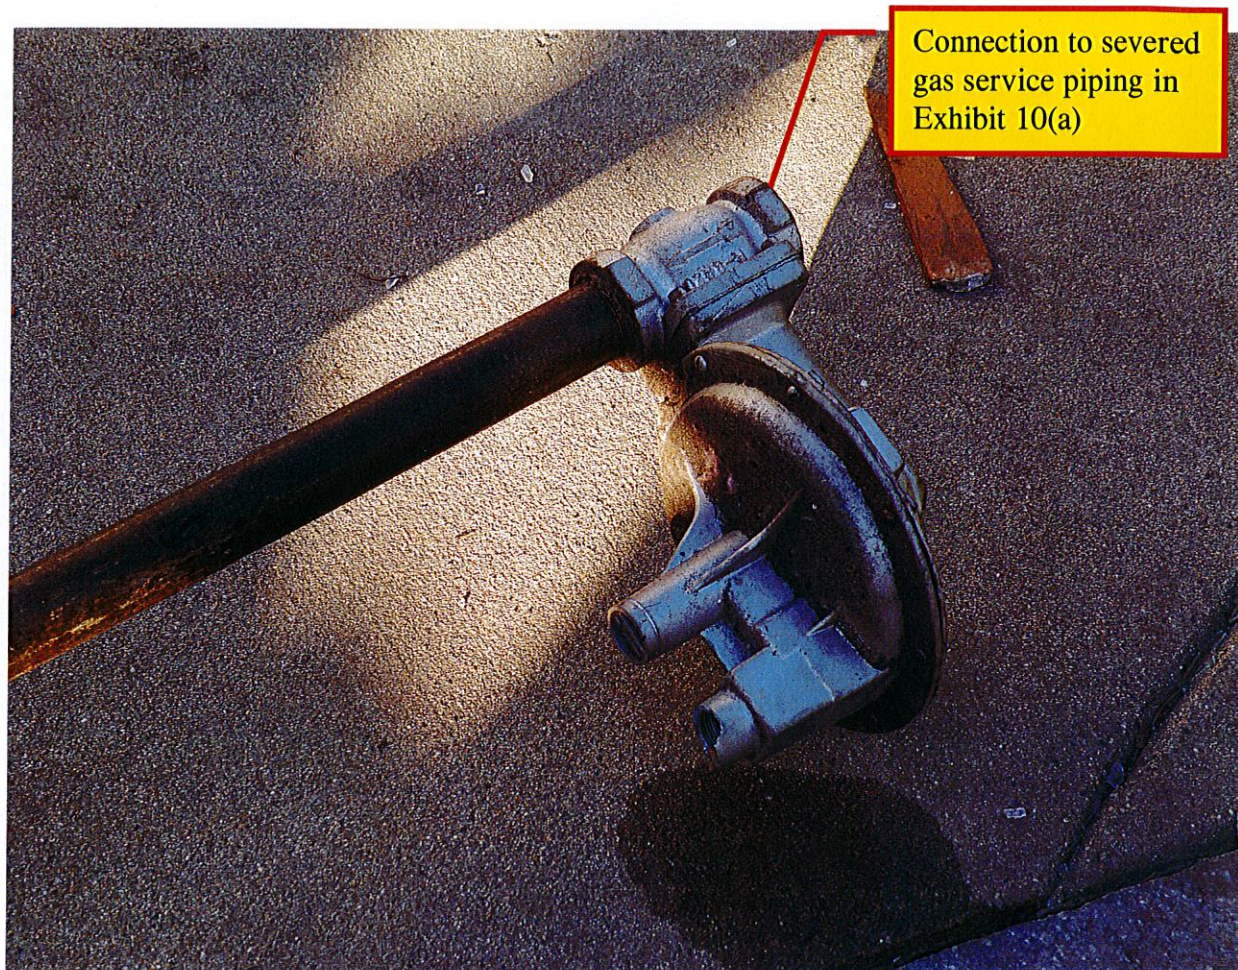
Exhibit 10(b) – Service Regulator Severed from the Gas Service Piping Inside of 17 Danny Road
